Performance of Structural Insulated Panel Walls under Seismic Loading

Research Paper
FPL–RP–704

September
2020

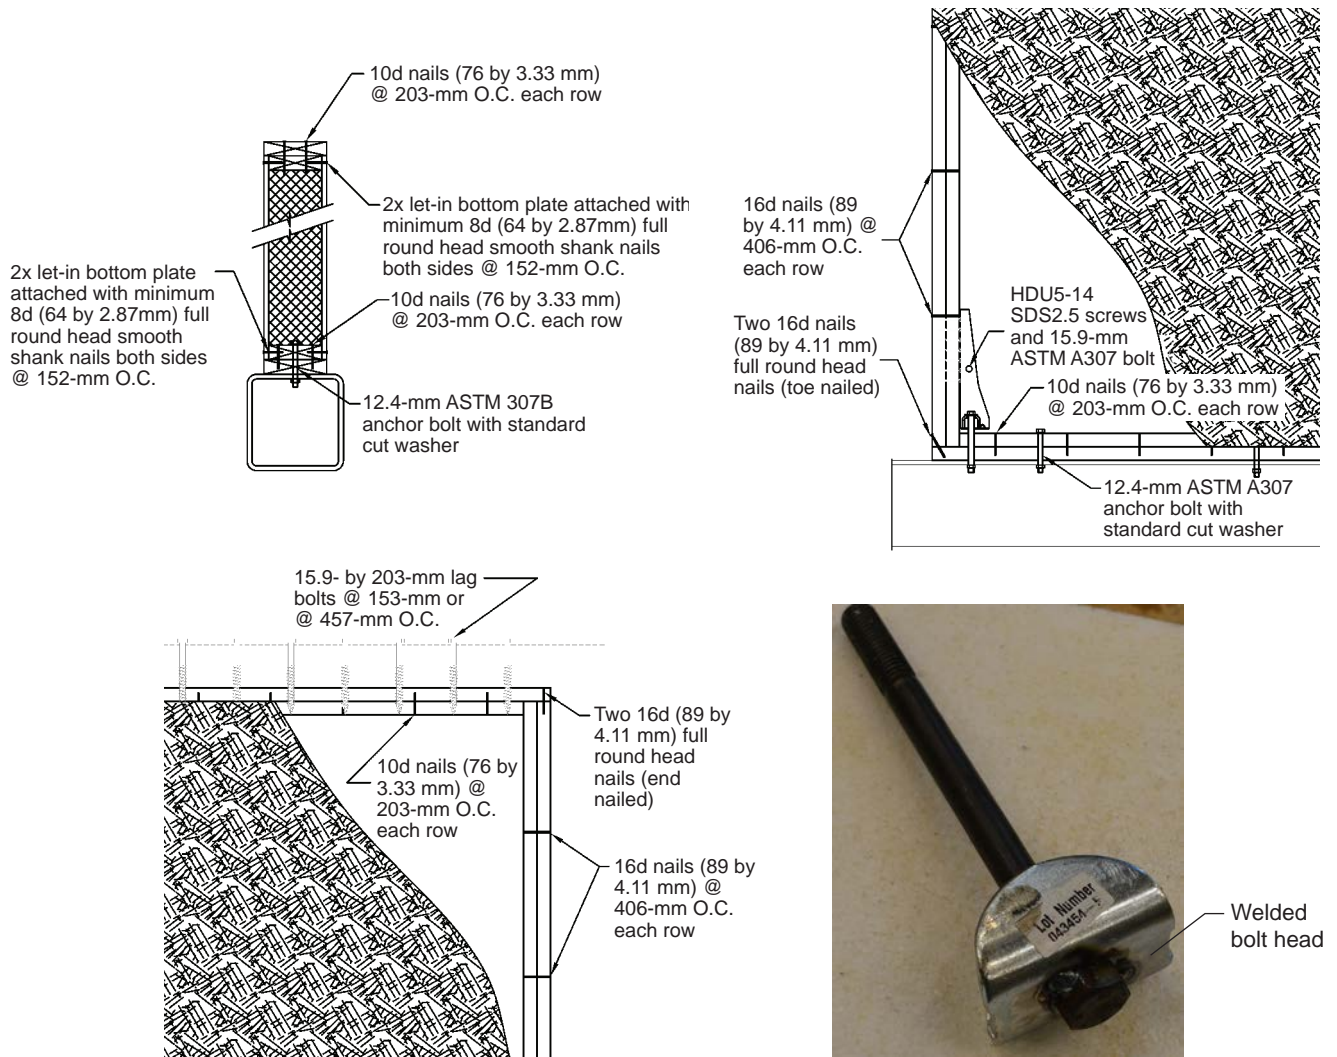
Figure 1. Construction details for all SIP wall configurations.

Although the research project can be broken into three distinct configuration features, all specimens were 2.4-m (8-ft) tall and constructed with common attributes. The nailing schedule, end-posts, hold-downs, and spline configurations were consistent across all specimens. Common features will be discussed followed by details specific to each of the three distinct configurations. Table 1 lists the common construction details, and Table 2 lists the fastening schedules for all the constructed walls. Figure 1 shows the general construction details consistent for all of the constructed single- and multiple-panel walls.

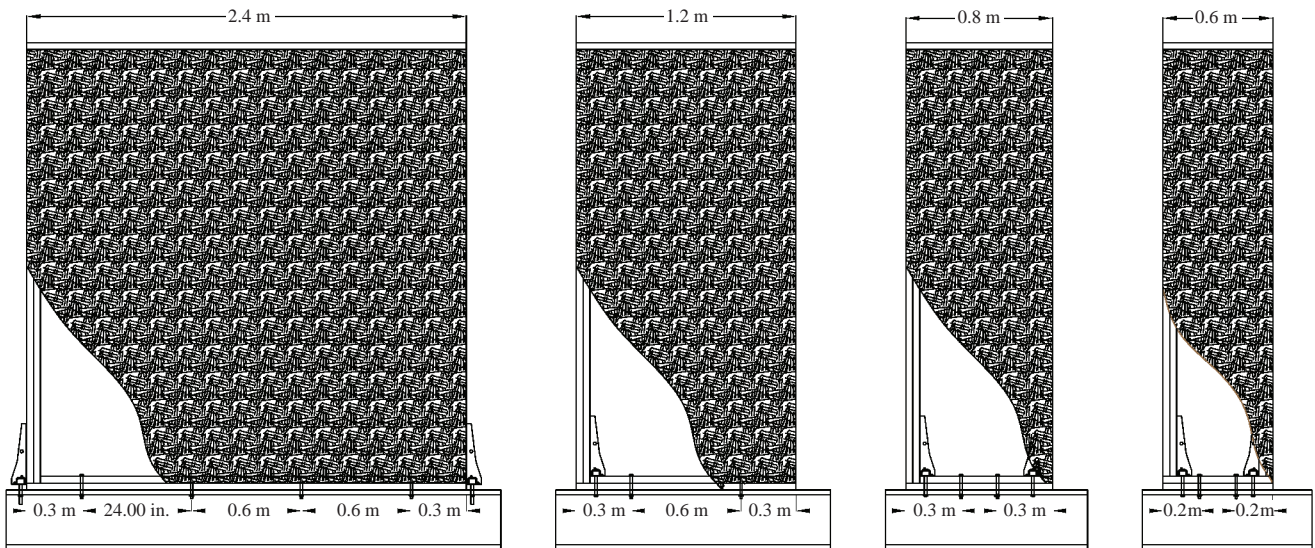
Figure 2. Wall configuration for single-panel SIP wall tests with and without hold-downs.

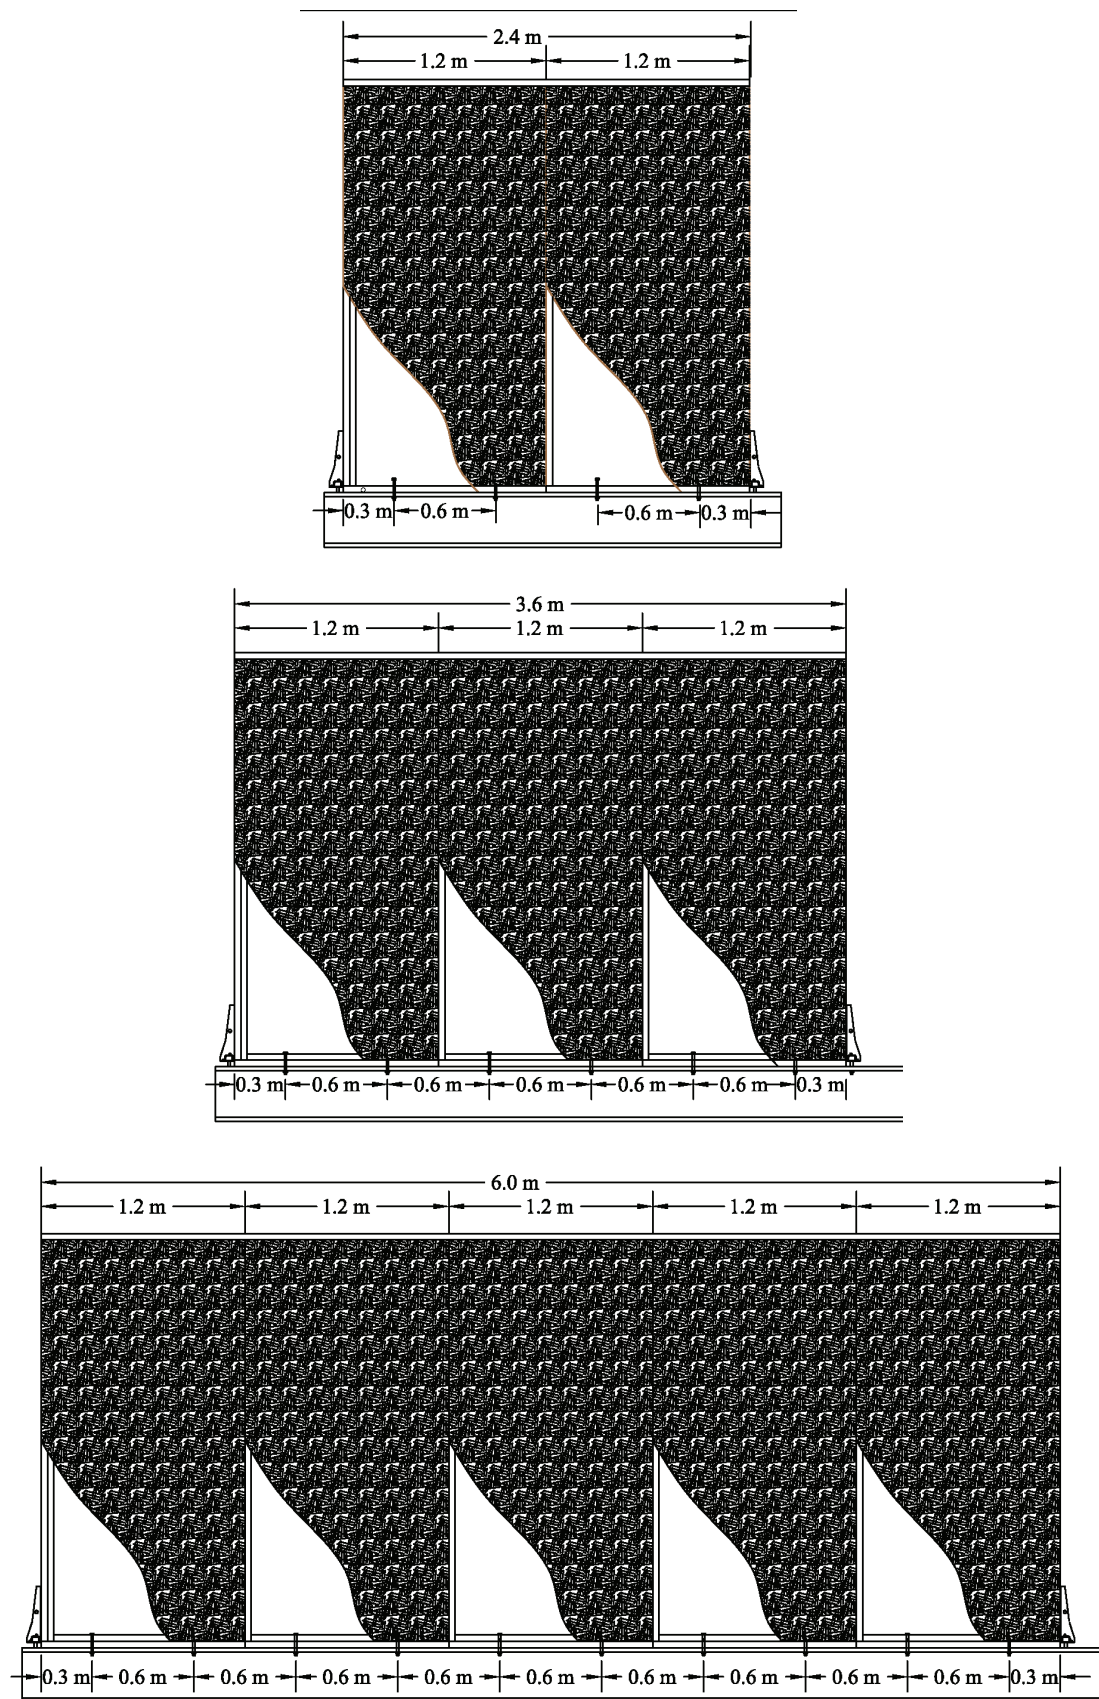
Figure 3. Configurations for multiple-panel SIP walls without openings.

Most SIP wall lines are constructed with a series of interconnected individual panels. Three multiple-panel walls of varying total length (2.4, 3.6, and 6 m (8, 12, 20 ft)) using a block spline configuration were evaluated (Figs. 3 and 4). Each 1.2- by 2.4-m (4- by 8-ft) single panel for all the multiple-panel specimens contained two anchor bolts. The let-in framing and cap plate or sill plate framing were continuous across all spline joints. Butt joints were staggered to avoid introducing a vulnerability at the same location. Hold-downs were only placed at the end

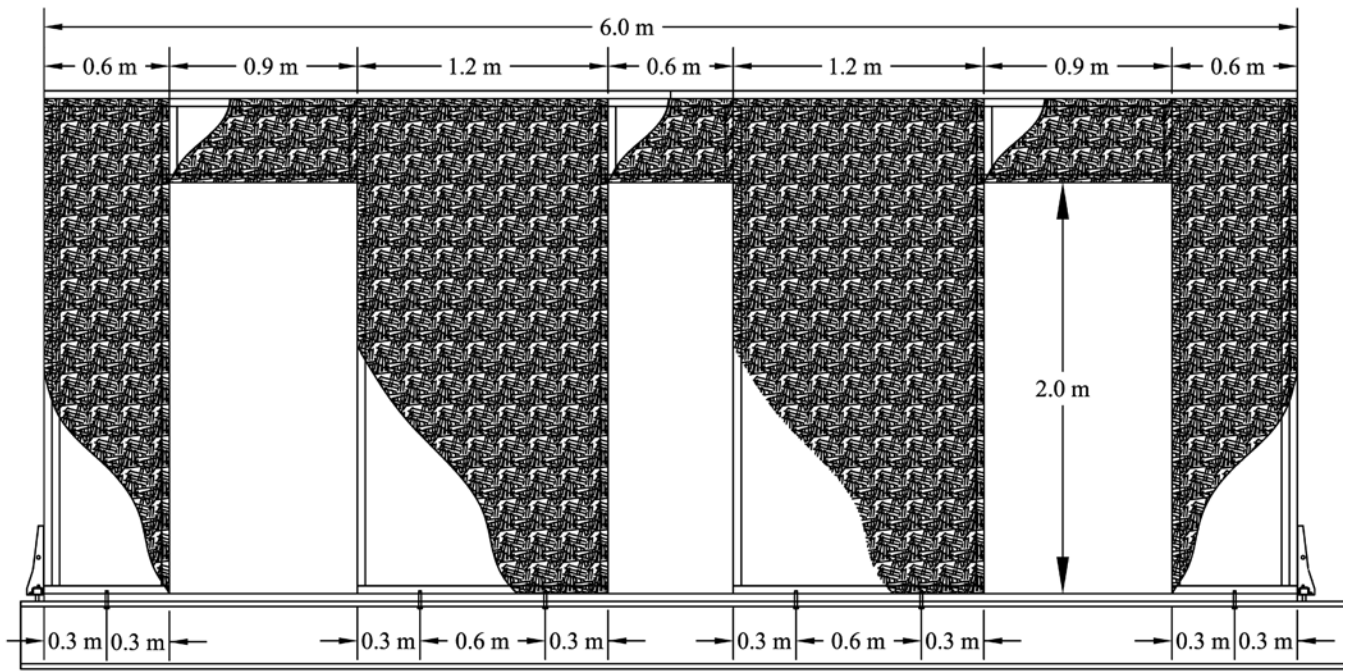
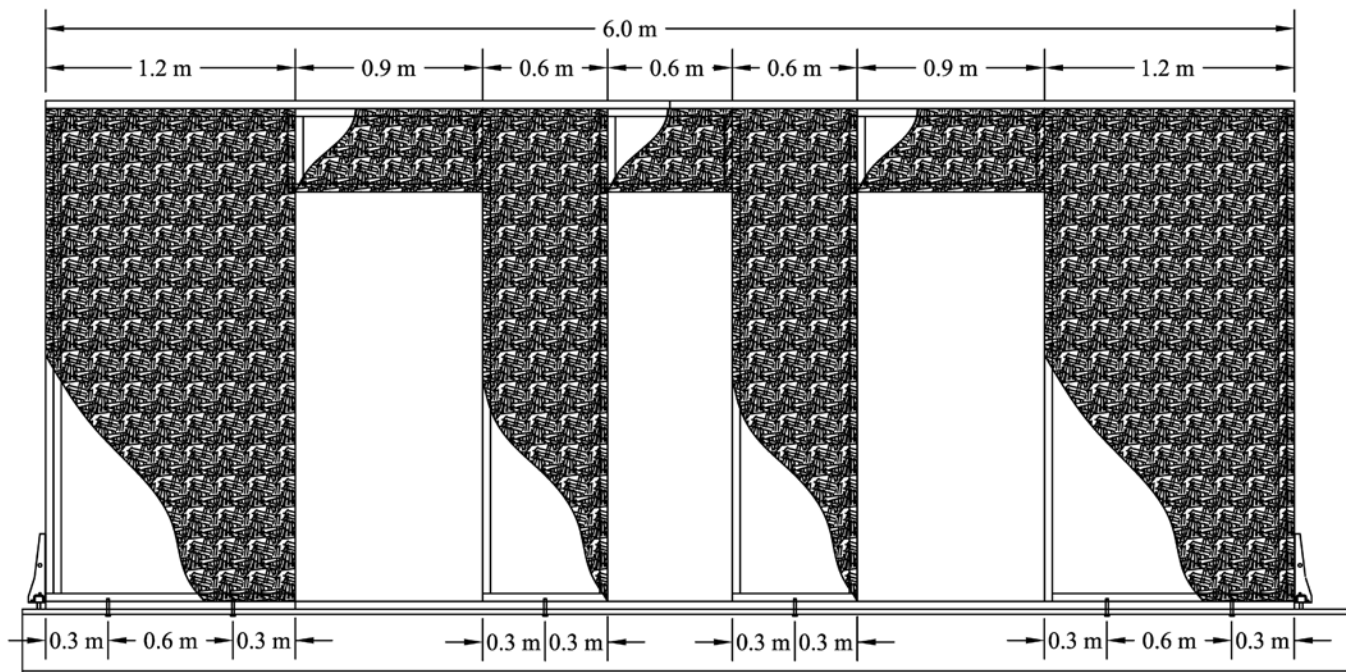
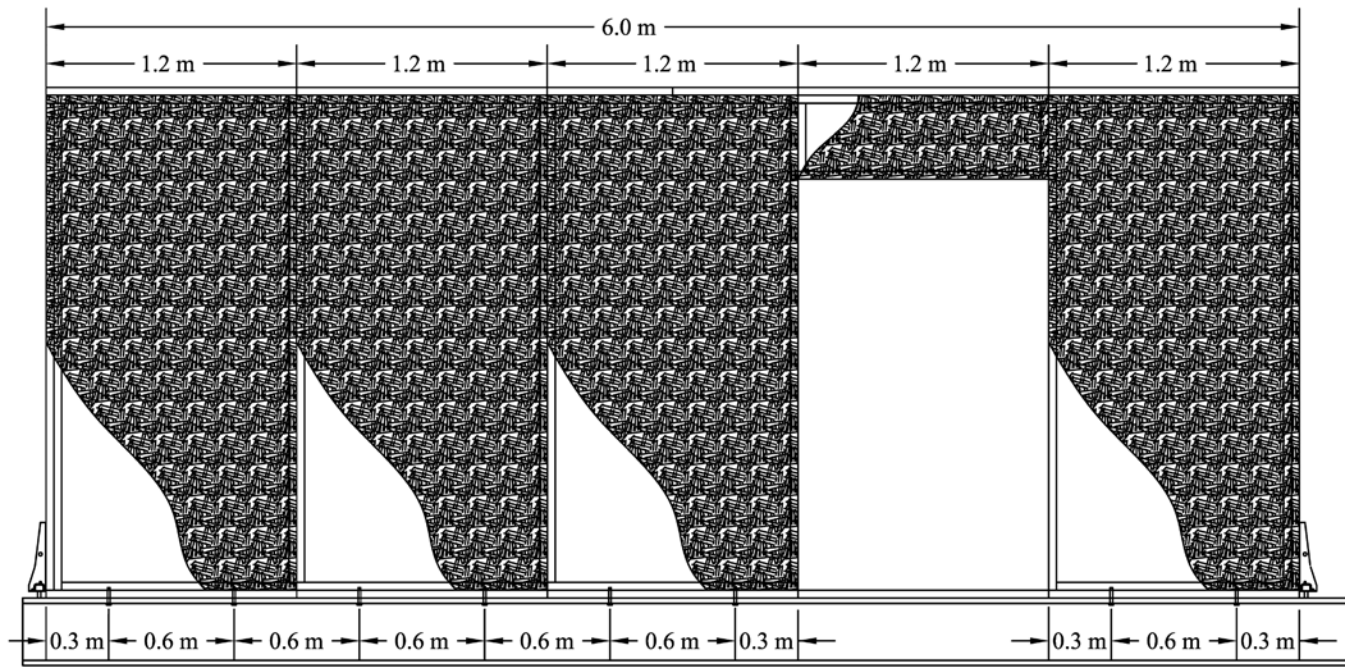
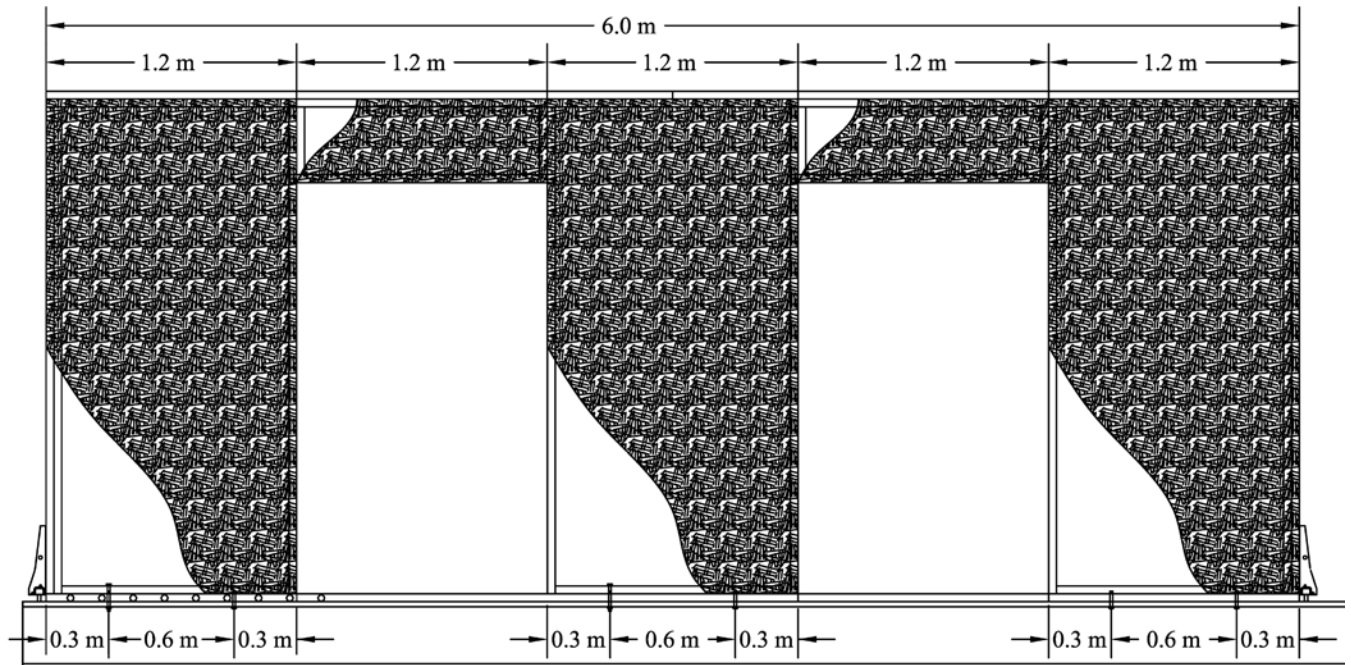
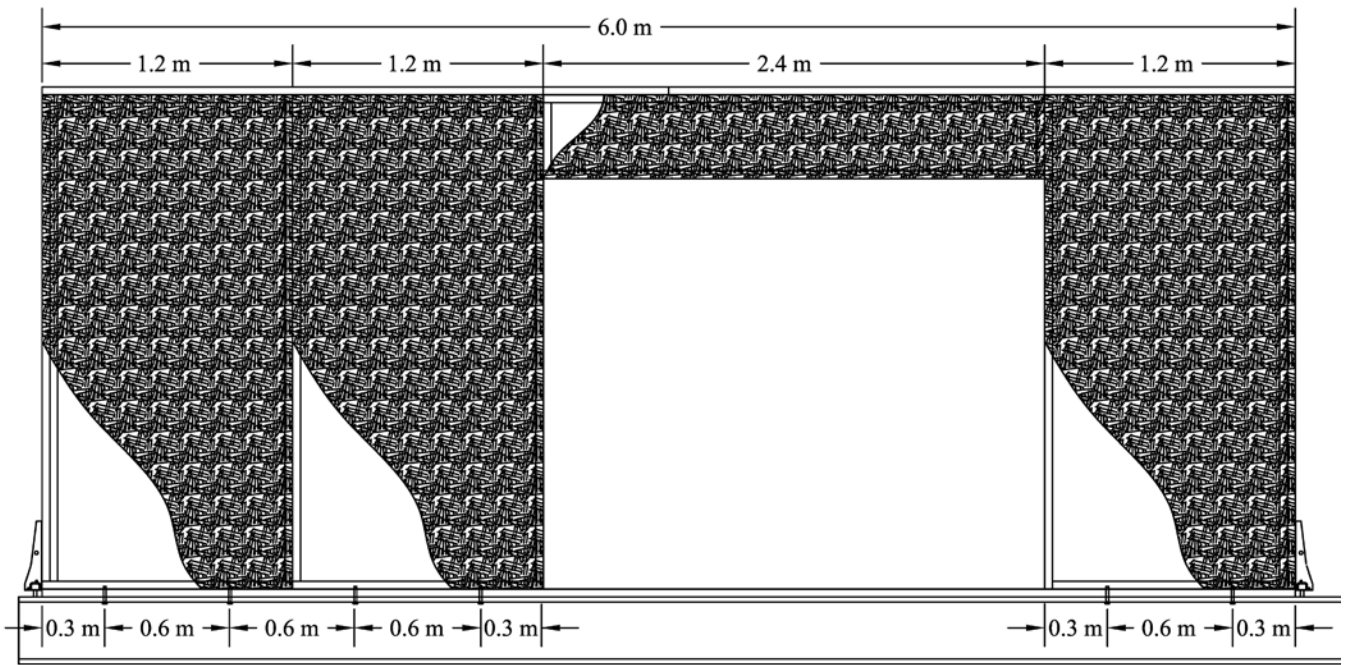
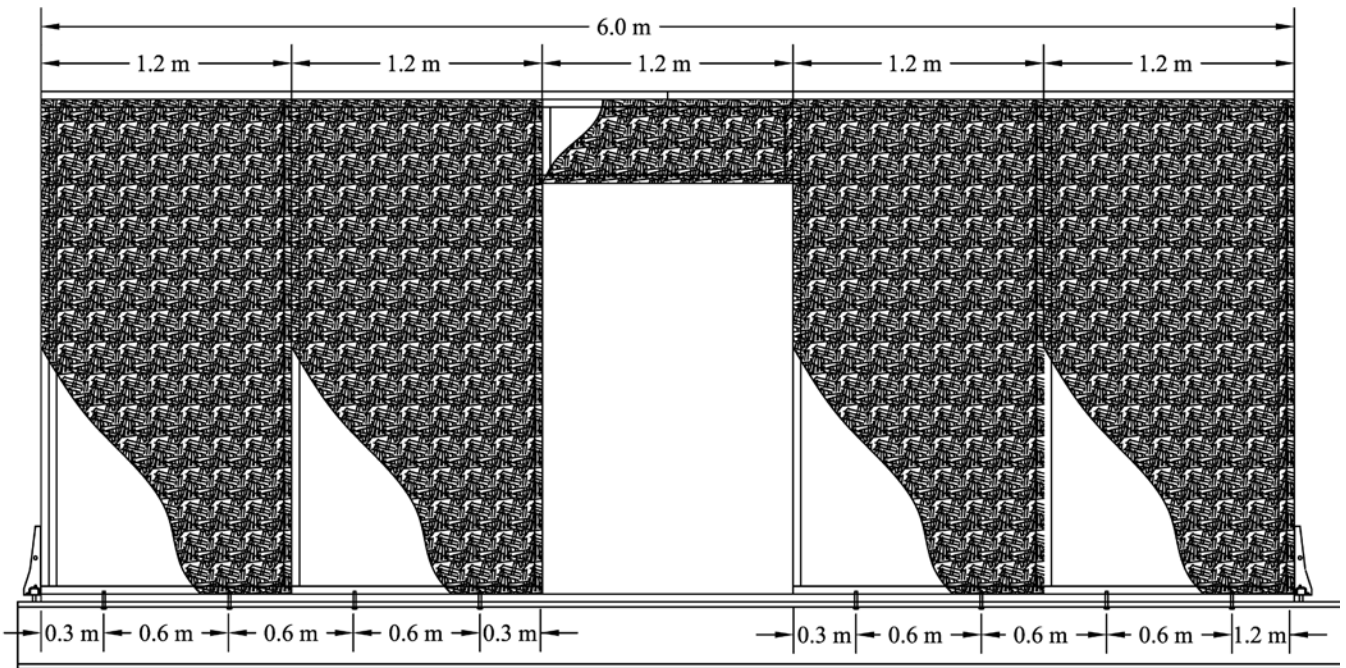
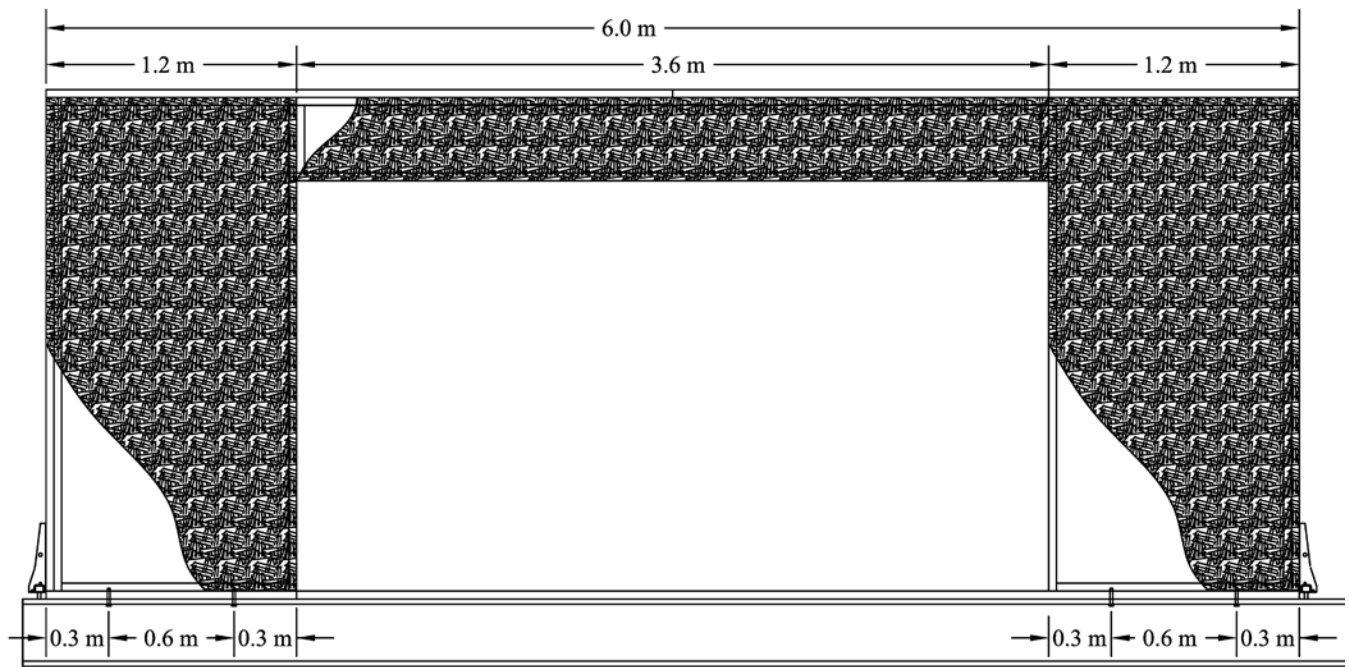
Figure 5. Configurations for multiple-panel SIP walls with openings.

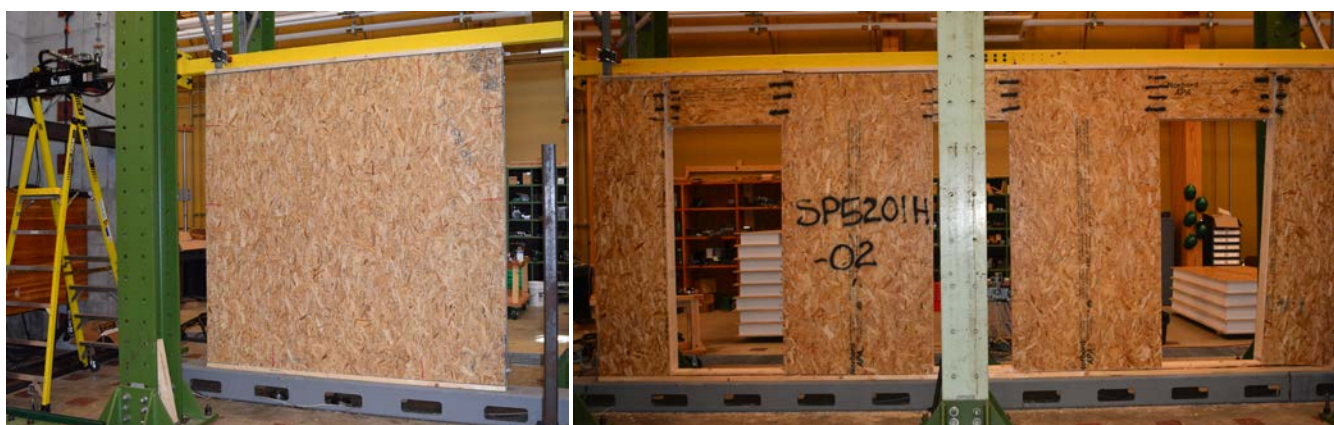
Figure 8. Testing configuration for single- and multiple-panel SIP specimens.

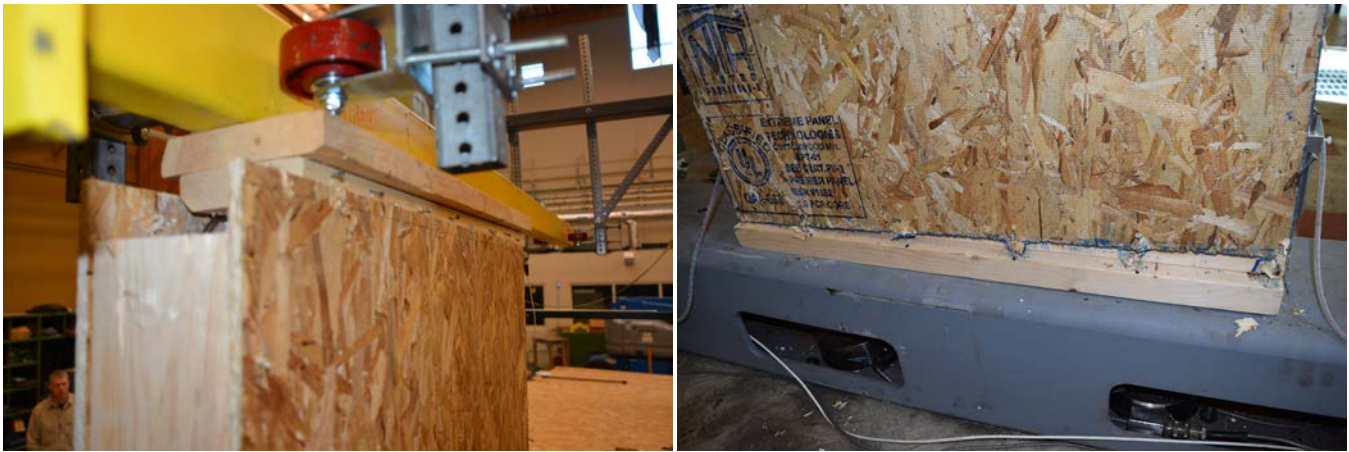
Figure 9. Failure modes for single-panel SIP tests.

For all the single SIP walls with hold-downs, the ultimate mode was the failure of the connection between the let-in framing and OSB panel (Fig. 9). For the 1:1 and 2:1 aspect ratio walls with hold-downs, the walls both slid and rocked during loading, whereas only rocking was observed for the 3:1 and 4:1 aspect ratio walls. Compared with the panels with hold-downs, panels without hold-downs had more failures between the bottom let-in framing and the OSB panel or simultaneous failures at the top and bottom let-in framing and panel. Some let-in framing failed because of cross grain bending. Both the video and graphs of panel uplift showed that the addition of hold-downs significantly decreased the uplift of the end-post and provided an additional load path.

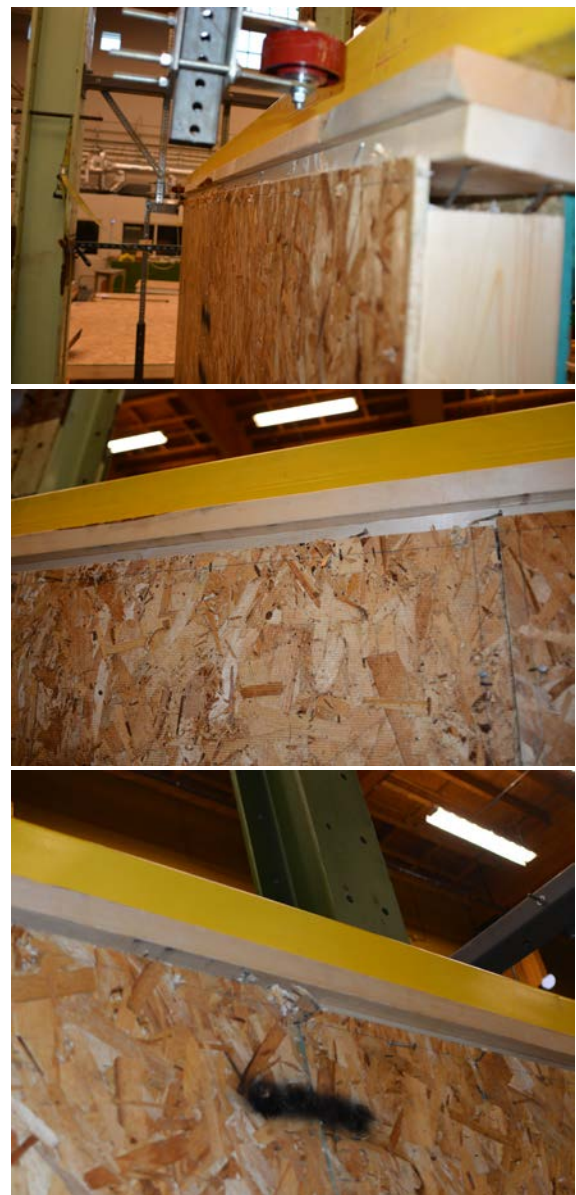
Figure 10. Failure modes for multiple-panel SIP wall without openings.

As with the single-panel tests with hold-downs, all the multiple-panel tests with no openings ultimately failed because the connection between the top let-in framing and the OSB could no longer transfer the loading (Fig. 10). During the test, sliding of the entire wall systems was observed, whereas the individual panels exhibited a rocking behavior. Because of the rocking of the individual panels, the top and bottom corners of adjacent SIP panels exhibited localized crushing. Figure 10 shows typical failures seen for the multiple-panel SIP walls without openings.

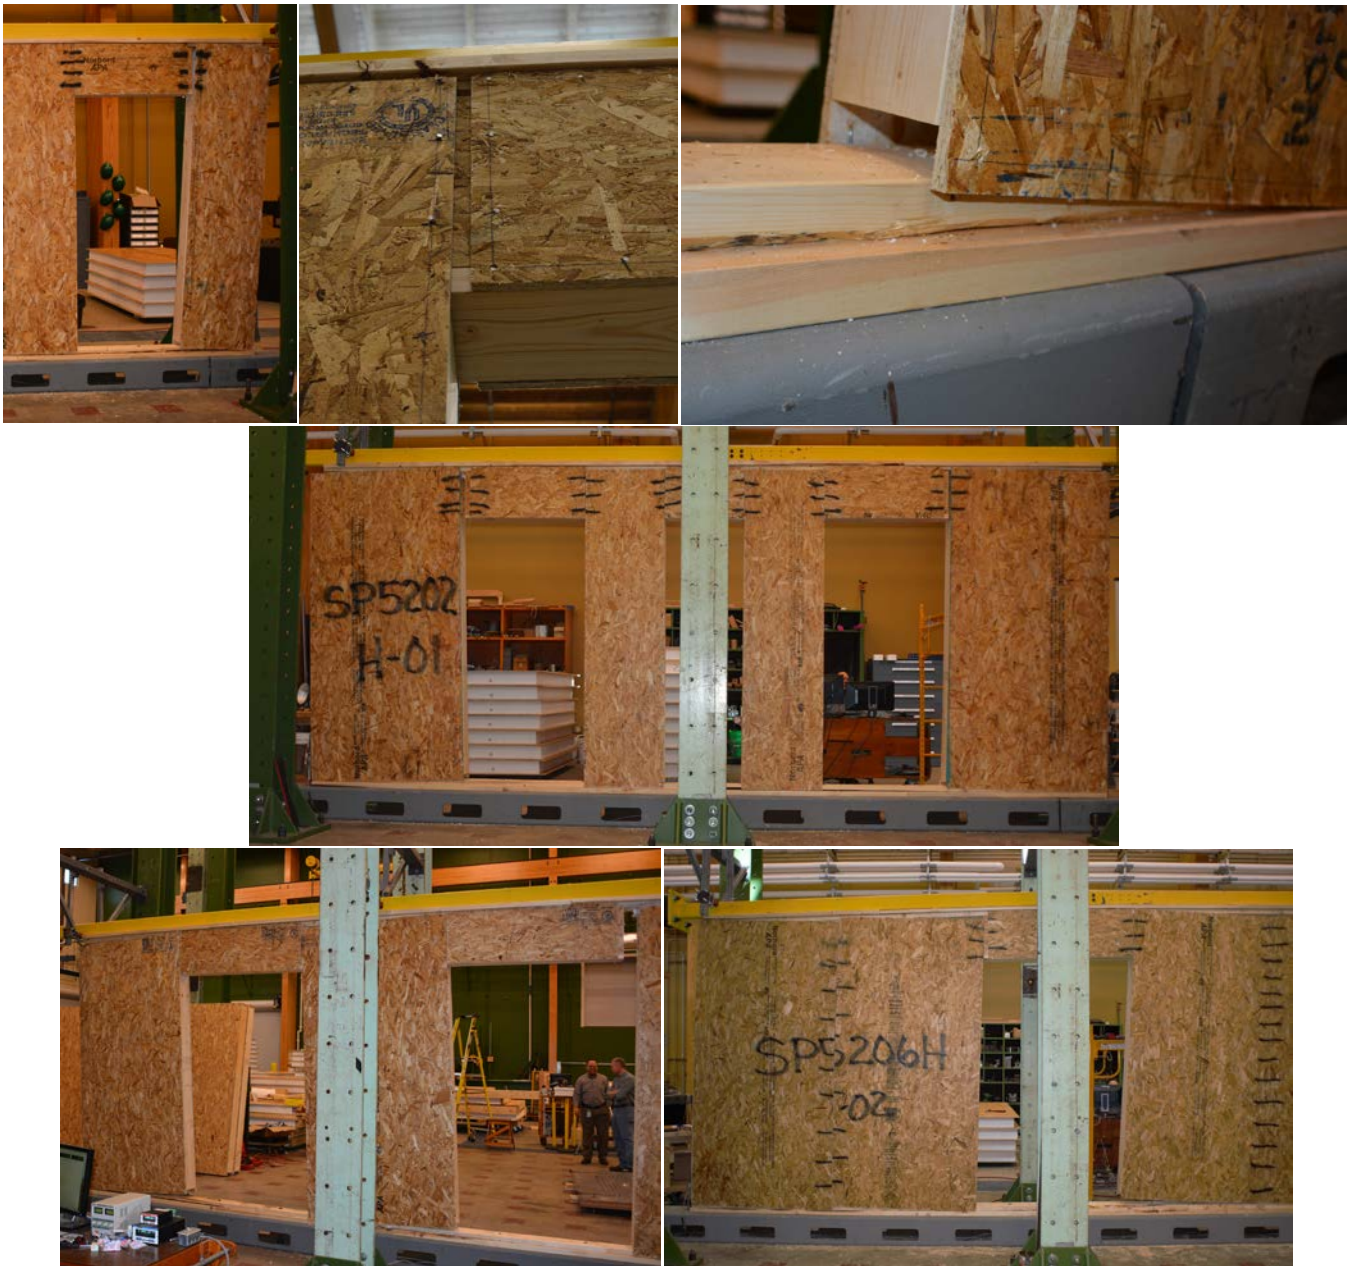
Figure 11. Failure modes for multiple-panel SIP walls with openings.

It was difficult to visually determine precisely when the multiple-panel SIP walls with openings failed, but in general, the connection of the SIP header to the full-size SIP typically weakened and broke first. Depending on the configuration, the continuous built-up top let-in framing and cap plate continued to transfer load to the remaining full-size panels. Upon continued loading, the full-size panels continued to resist applied load via rocking. This led to loosening of the panel-to-panel connection, but the final failure was the let-in framing to panel connection at the top or bottom of the remaining SIP wall. Figure 11 shows

typical failures seen for the multiple-panel SIP walls with openings.

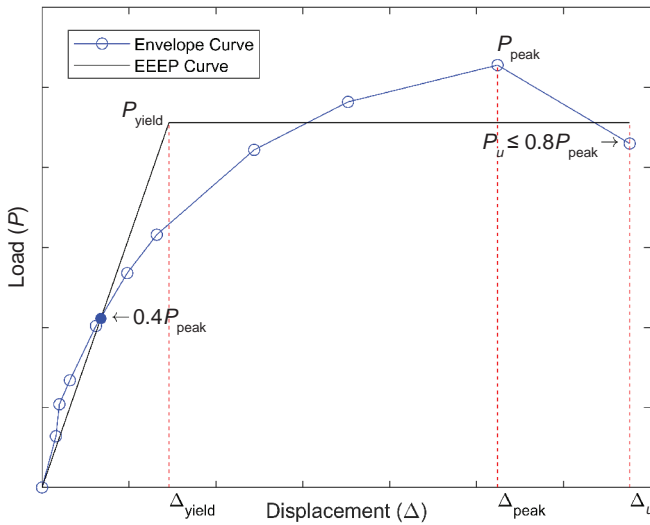
Figure 12. Equivalent energy elastic-plastic (EEEE) curve and parameters.

Because of the difficulty in identifying the precise yield strength of the nonlinear SIP resistance deformation response, the equivalent energy elastic–plastic (EEEP) model was used to develop design parameters as shown in Figure 12. The model assumes the energy dissipated

by the test wall during the reversed cyclic loading is equivalent to the energy found under the corresponding bilinear elastic-plastic curve. Only the backbone curve of the reversed cyclic test data was used in the EEE model energy calculations. These parameters included Δ_{yield} , displacement at P_{yield} , Δ_u , displacement at P_{peak} , P_u , and load corresponding to the failure limit. The EEE model approach was used on all the single- and multiple-panel SIP wall cyclic test data. From the backbone curve, P_{peak} , the maximum absolute load resisted by the specimen and ultimate displacement, Δ_u , were determined. Using these values, the yield load, P_{yield} , can be determined by the following expression:

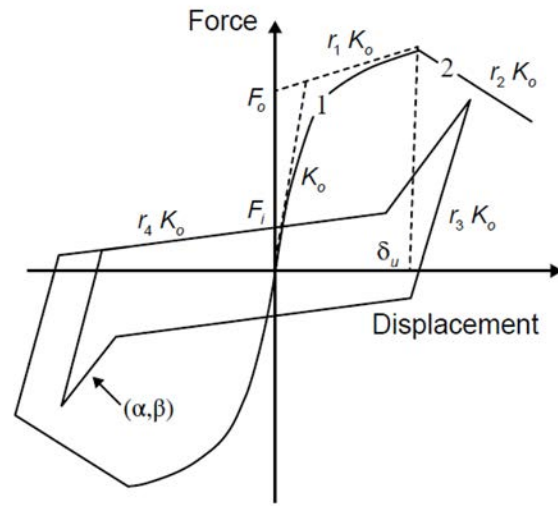
Figure 13. Modified Stewart hysteretic model and associated parameters.

modified Stewart and the evolution damage parameter models (Pang and others 2007). For all tested walls, the modified Stewart model was fit to the experimental data. The modified Stewart model uses 10 parameters, highlighted in Figure 13, to describe the hysteretic behavior of the structural panel.

A MATLAB (Mathworks Inc., Natick, Massachusetts, USA) program developed during the NEESWood program was used to optimize the 10 modeling parameters while minimizing the cumulative energy difference between the experimental and model behavior. Average modified Stewart modeling parameters for all SIP wall configurations are listed in Tables 11 to 13. In general, before failure, the modified Stewart model adequately followed the experimental data as observed in the difference between experimental and model cumulative hysteric energy. Appendix C contains tables and cyclic load-deformation curves for experimental and modified Stewart models for all tested walls.

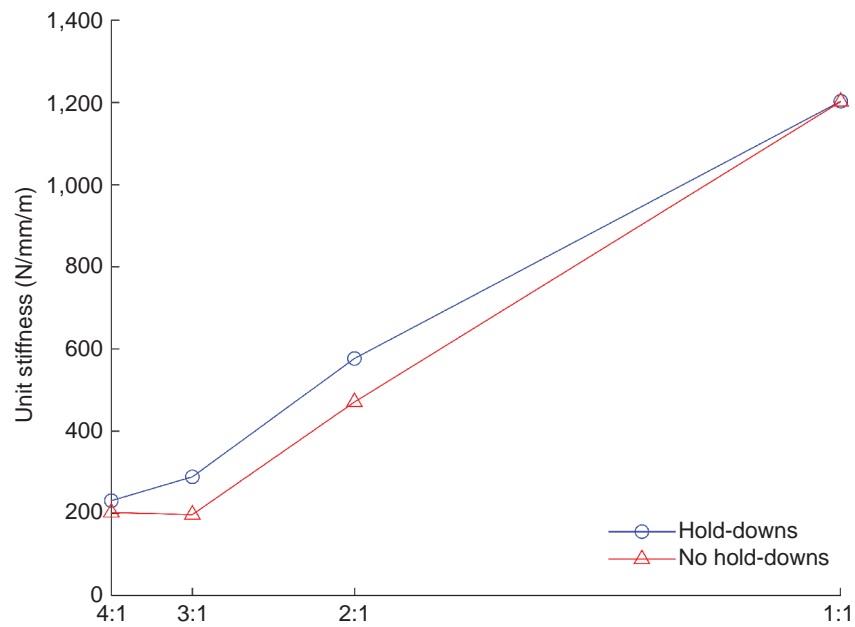
Figure 14. Unit stiffness for single-panel SIP tests with different aspect ratios.

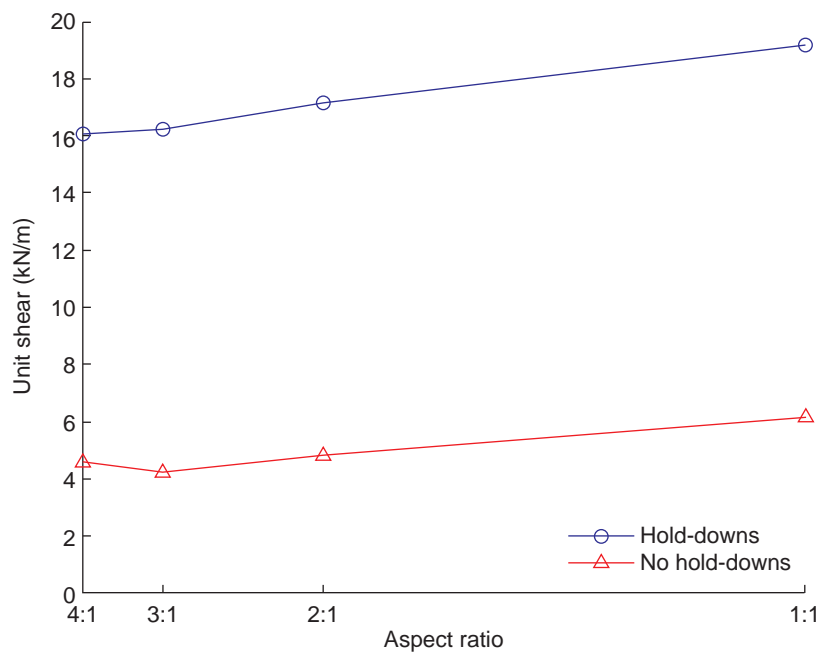
Figure 15. Unit strength for single-panel SIP tests with different aspect ratios.

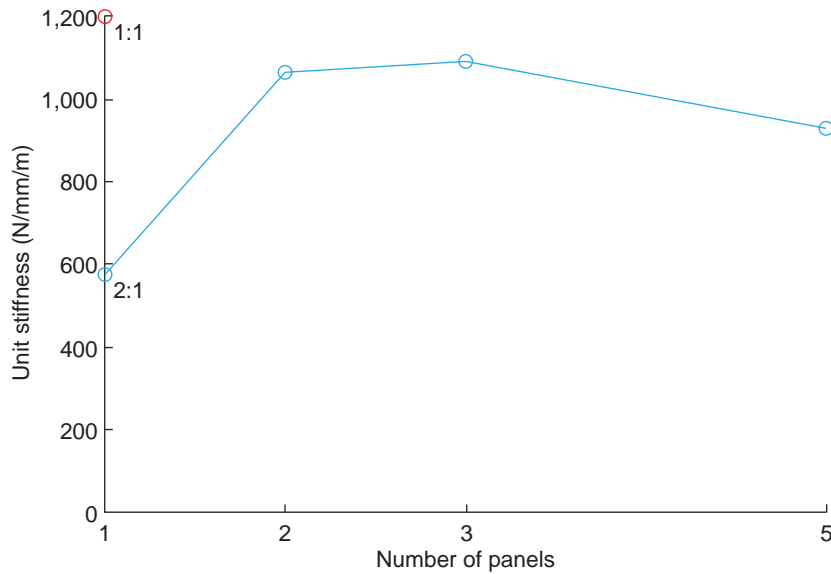
Figure 16. Unit stiffness for multiple-panel SIP tests without openings.

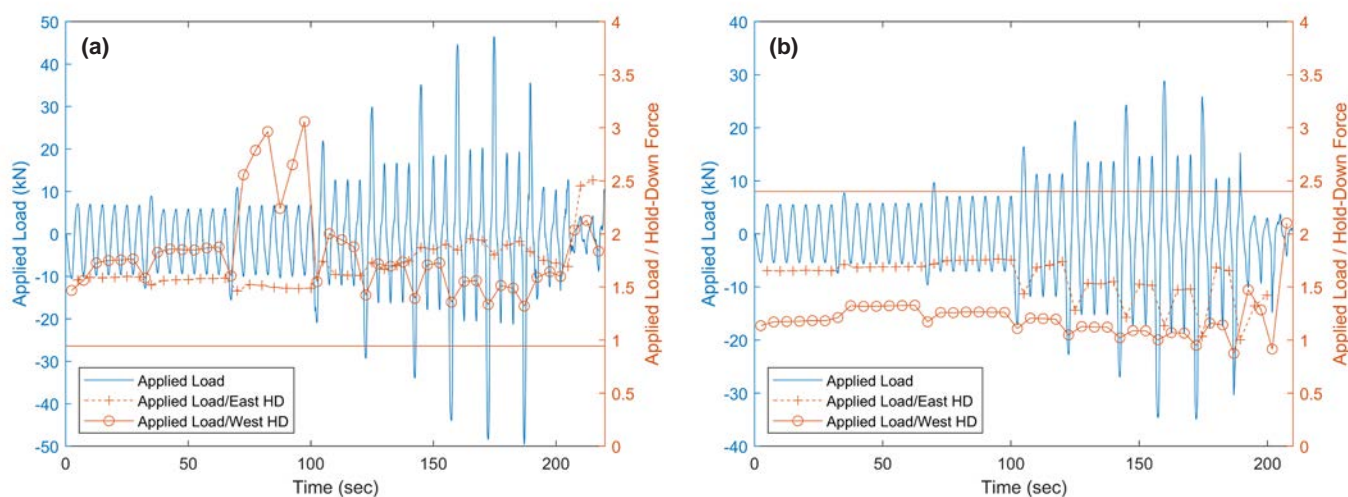
Figure 18. Ratio of applied load to hold-down force for (a) a representative 2.4- by 2.4-m panel and (b) configuration 207 of the multiple-panel wall with openings.

load to the hold-down force was calculated. Figure 18 illustrates hold-down forces with respect to applied loading for a 1:1 aspect ratio single-panel wall and a Configuration 207 multiple-panel wall with openings (Table 7). For the single-panel wall, calculated ratios were above the theoretical condition (constant line), which assumes that only the hold-downs resisted the overturning forces. Values above the constant line indicate that other structural components, e.g., anchor bolts, are providing

load paths to resist the applied overturning forces. In the case of multiple-panel wall configurations with openings, Configuration 207 represents the assembly with the largest opening area. For this configuration, the hold-down ratios were below the theoretical ratio (Fig. 18b), which indicates that the maximum resisting moment was not being achieved to resist the applied force.

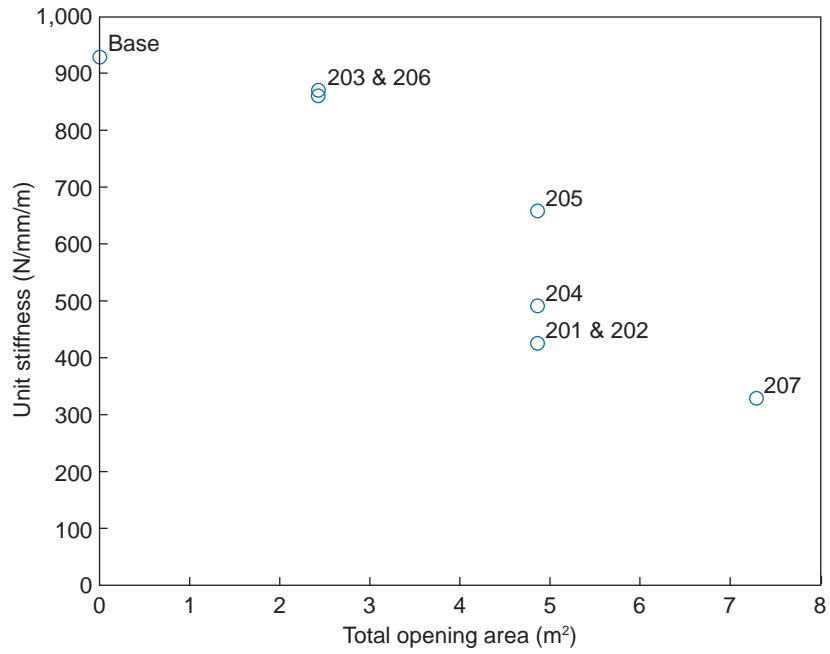
Figure 19. Unit shear wall stiffness for multiple-panel SIP tests with openings.

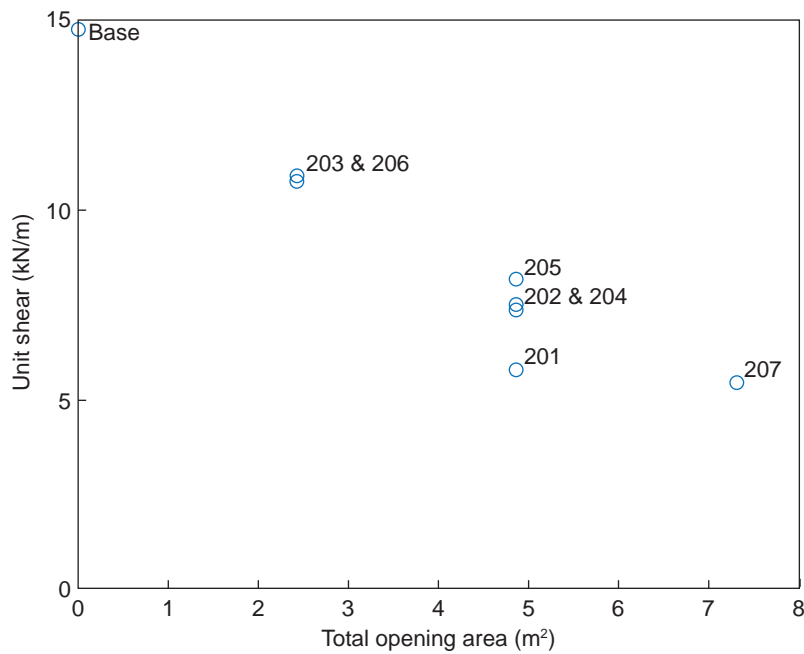
Figure 20. Unit shear wall strength for multiple-panel SIP tests with openings.

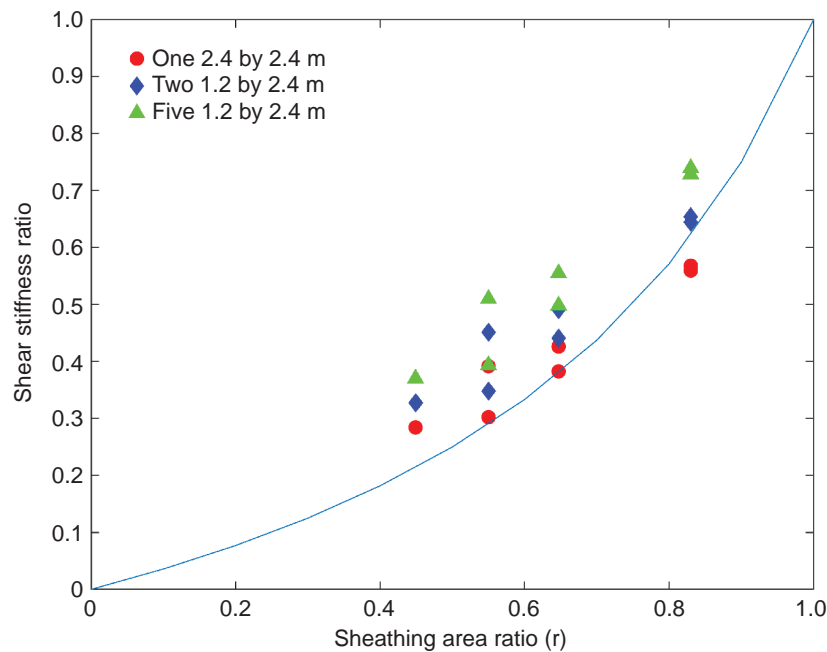
Figure 21. Perforated shear stiffness ratio using three baseline configurations for shear strength ratio determination.

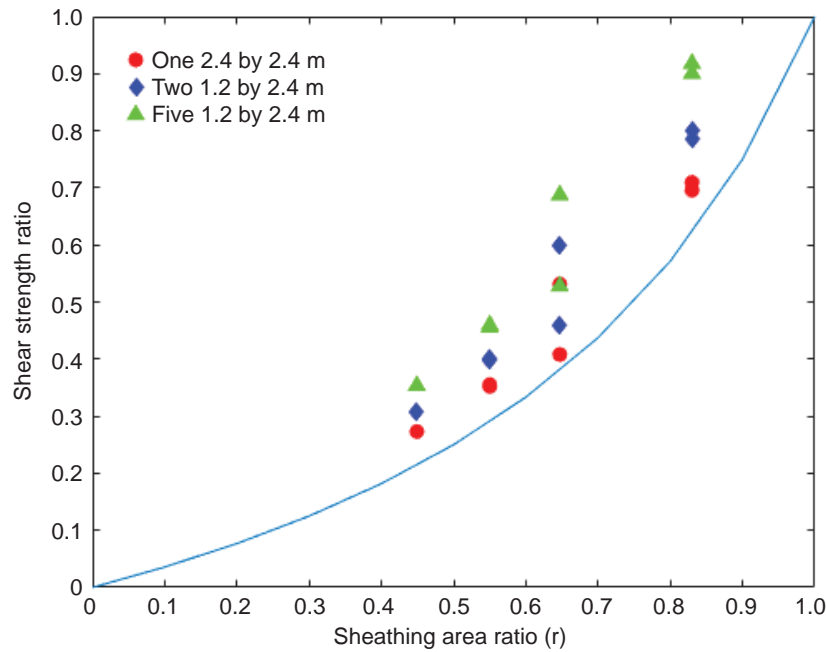
Figure 22. Perforated shear strength ratio using three baseline configurations for shear strength ratio determination.

Figure 22 shows that for any choice of baseline, the PSW method gave conservative results for all shear strength ratio predictions. All data points were above the curve and generally followed the shape of the relationship with the sheathing ratio. The most conservative results came from using the five 1.2- by 2.4-m (4- by 8-ft) panel configuration as the baseline. Based on these configurations, it appeared to be justified to apply the PSW approach to SIP wall configurations with openings. Furthermore, using a 2.4- by
